MECHANICVILLE RESERVOIR DAM

SARATOGA COUNTY, NEW YORK
INVENTORY NO. N.Y. 1061

PHASE I INSPECTION REPORT
NATIONAL DAM SAFETY PROGRAM

NEW YORK DISTRICT CORPS OF ENGINEERS
JUNE, 1981

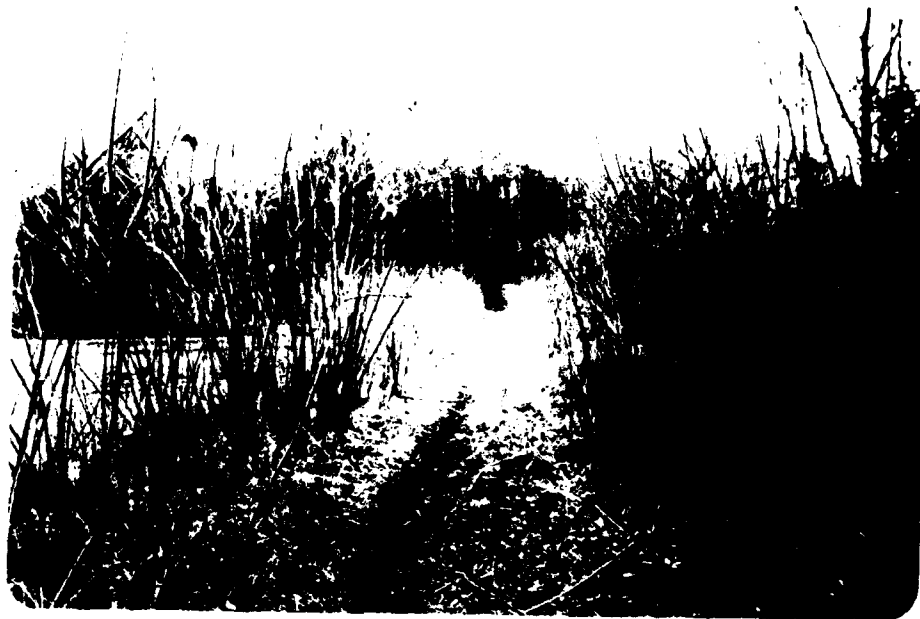
In spite of these conditions, several deficiencies were observed on this structure. The crest of the embankment was fairly level, although there were some low spots. A motor bike path had been worn along the entire length of the crest.

Embankment Crest; Note Brush Growing on Dam

Several other deficiencies were noted on this structure. The worst of these deficiencies were trees and brush growing on the entire embankment. All trees and brush should be cut and removed as soon as possible to permit a detailed inspection of the embankment. The remainder of the deficiencies should be corrected within 12 months of the date of notification.

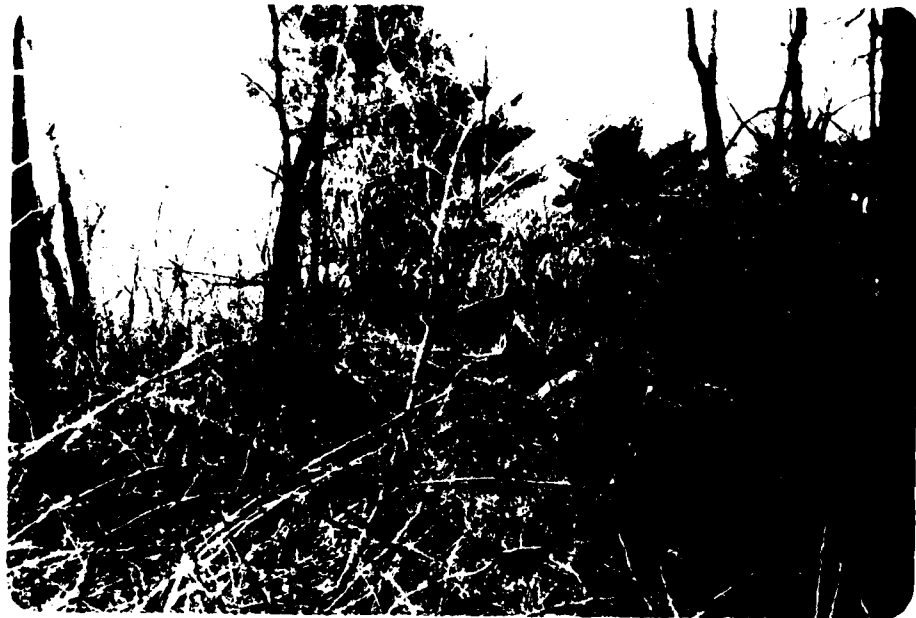
Several deficiencies were noted on the downstream slope. There was a soft area near the toe of the slope. This area extended for a distance approximately equal to the middle third of the embankment and was located in the middle portion of the embankment. There was one rectangular area near the right end (looking downstream) of the soft area where standing water was observed. However, there were no points of concentrated seepage. Another deficiency noted was that some bent trees were noted on the downstream slope. This could be an indication of movement of the slope. No cracks, sloughs or other indications of recent movements were noted, but the trees and brush prevented a detailed inspection of this area.

Downstream Slope of Embankment; Note
Trees and Brush Growing on Slope

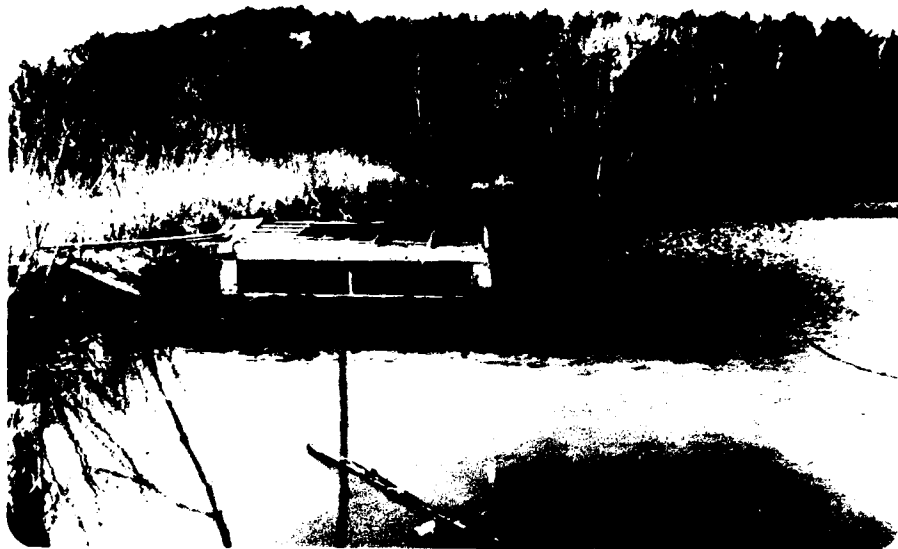
Concrete Drop Inlet Structure with
Timber Roof; Cast Iron Standpipe in Background

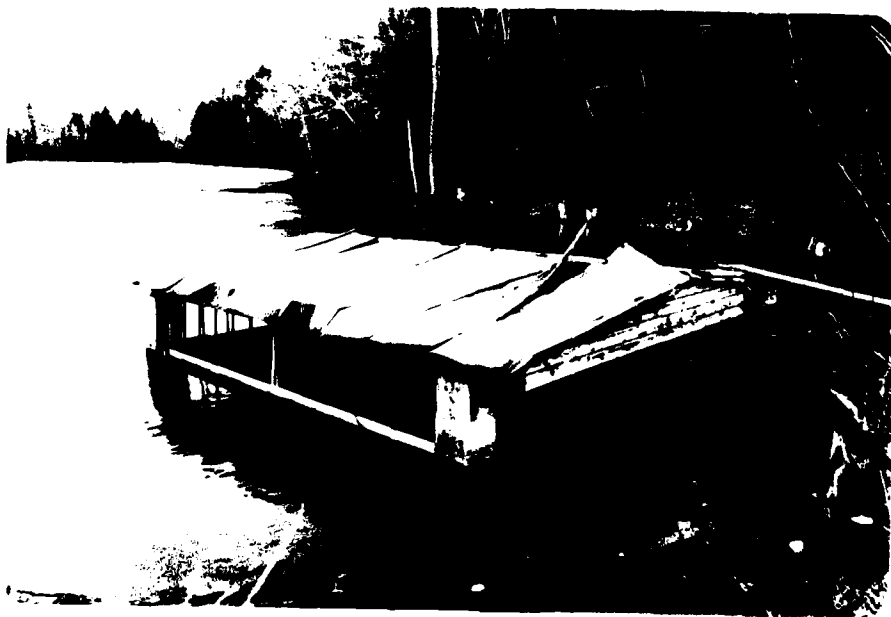
Drop Inlet Structure; Note Stop Logs in Place
on all Sides.

- a. Due to the serious deficiency in spillway capacity, remove the stop logs and lower the reservoir level pending the results of the detailed hydrologic/hydraulic analysis.
